# Water Flows in the Murray-Darling Basin: Observed versus expected Summary Report

February 2019

WENTWORTH GROUP OF CONCERNED SCIENTISTS

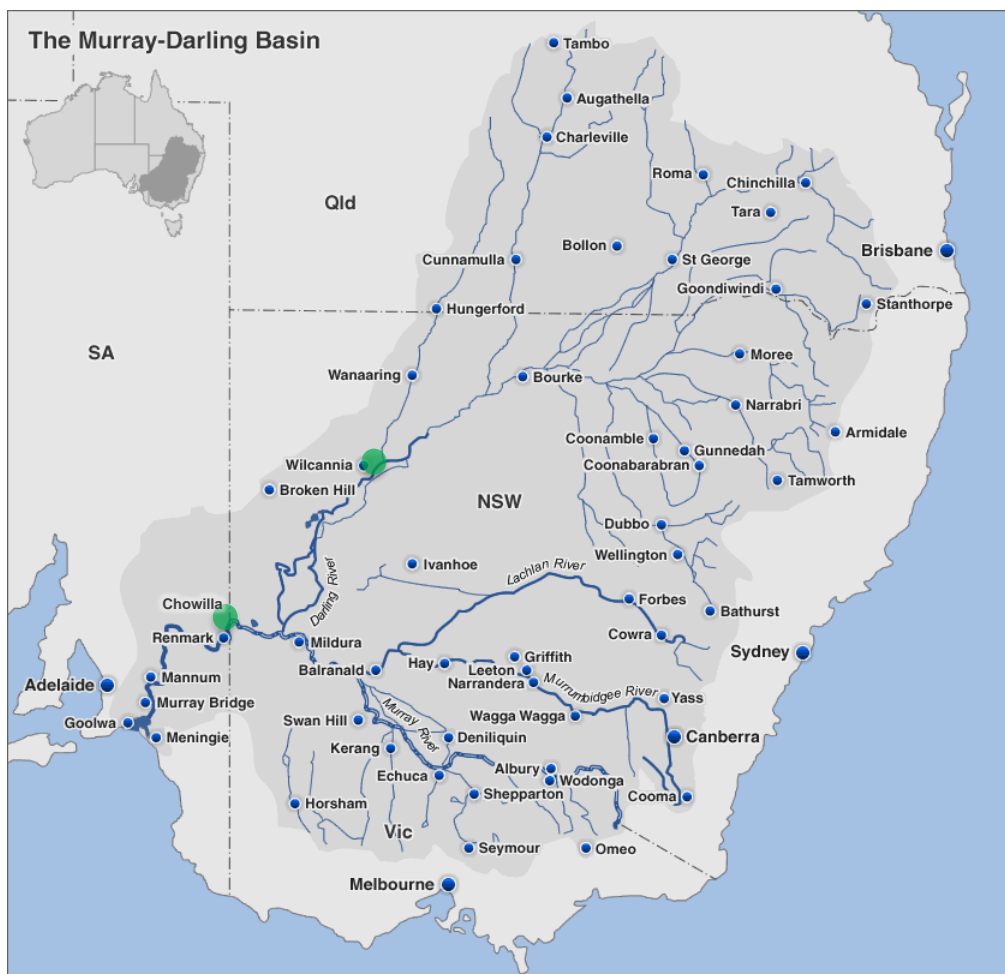
Figure 1: Map of Basin showing location of the Wilcannia on the Darling River above Menindee Lakes, and Chowilla on the Murray River near the South Australian border (source: MDBA).

To undertake this assessment, two river gauge sites were chosen which broadly represent flows in the northern and southern basins (Figure 1). These sites are:

- a) Chowilla on the Murray River, indicative of the volume of flows to South Australia as well as the health of the Murray River and associated wetlands and floodplains; and
- b) Wilcannia on the Darling River, indicative of the health of the Barwon-Darling system upstream of the Menindee Lakes.

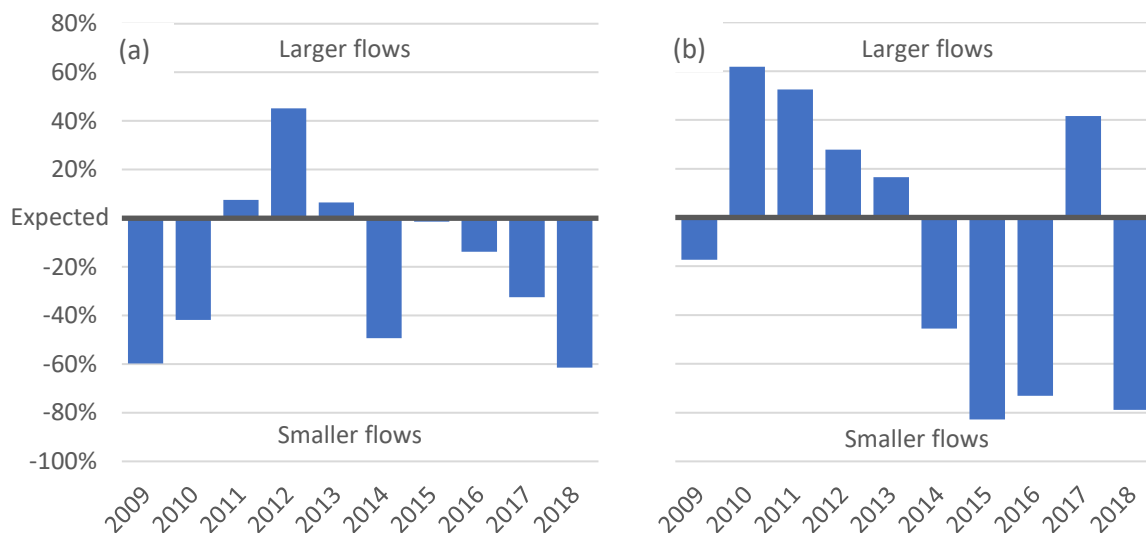
Figure 3: Annual difference in observed flows and expected flows at (a) Chowilla and (b) Wilcannia.

From Figure 3, for Chowilla we see that:

- In the wet years of 2010-2013 and 2017 only a single annual observed flow volume was substantially larger than expected. However, in the majority of all other years, annual observed flows are up to 60% smaller than expected after environmental water recovery.

For Wilcannia we see that:

- Observed flows were well above the Basin Plan expectation over the period 2010-2013 and 2017. These were exceptionally wet years, with large floods. However, as conditions became

drier, observed flows have been consistently smaller than expected under the Basin Plan with up to 80% smaller flows than expected.

- Only in the wet years were flows higher than expected. In all other years, they were lower than expected, in most cases substantially lower.
